NASA CR-120980  
BAC Report No. 8654-953003

# FINAL REPORT APPENDIX

## NONDESTRUCTIVE TESTS OF REGENERATIVE CHAMBERS

**FINAL REPORT - APPENDIX**  
**NONDESTRUCTIVE TESTS OF REGENERATIVE CHAMBERS**

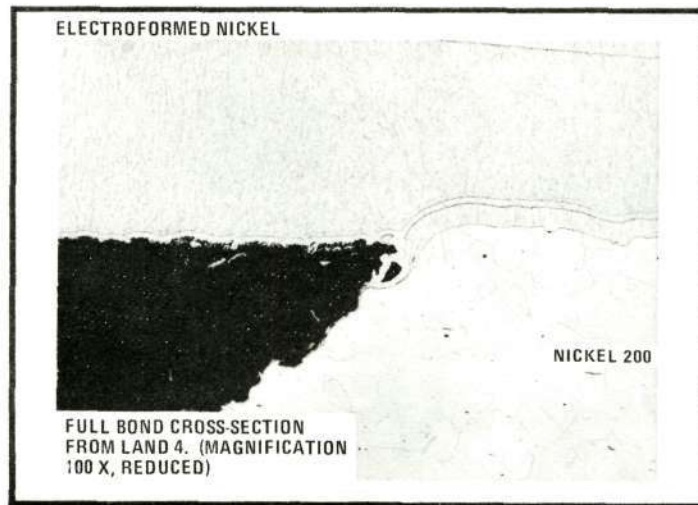
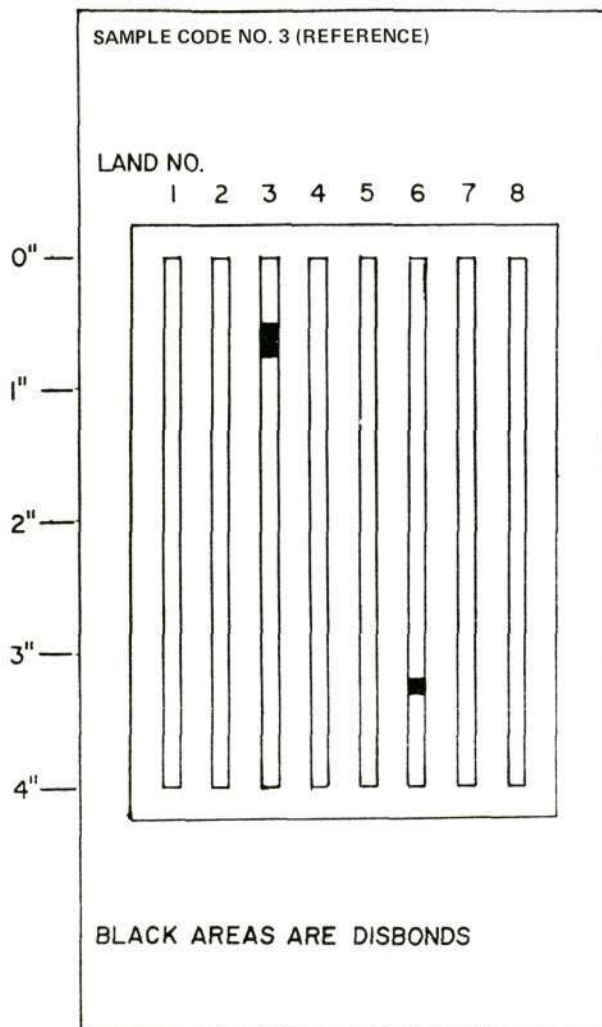
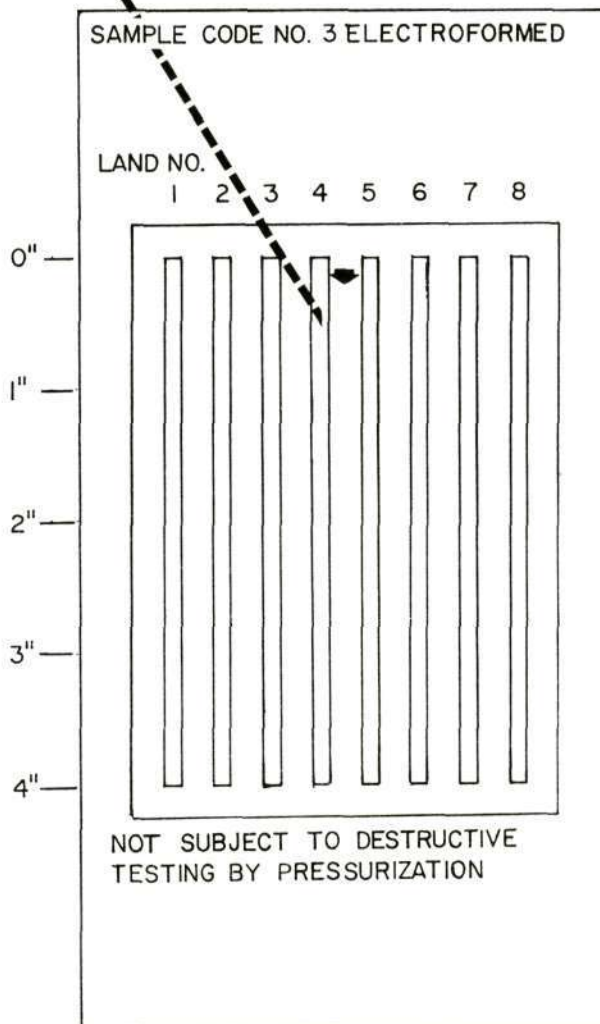
FIGURE A-1

ELECTROFORMED FULL BONDS WITH DEFECTS

TEST RESULTS ON ELECTROFORMED FULL BOND PANEL NO. 3

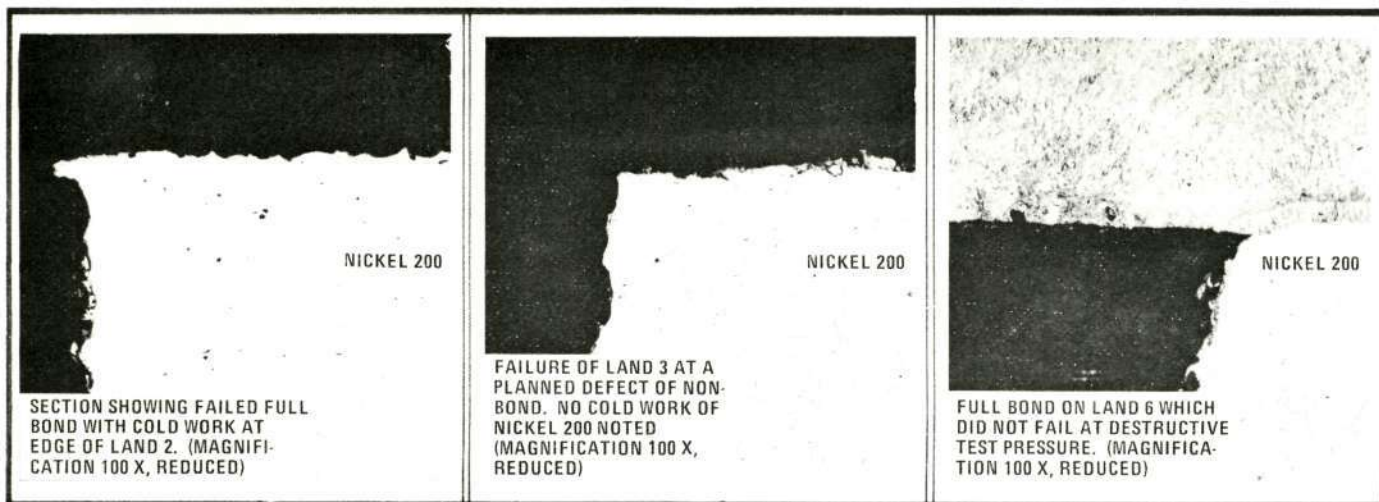
FIGURE A-2

TEST PRESSURE - 500 PSI

TEST RESULTS FOR ELECTROFORMED FULL BOND PANEL NO. 6

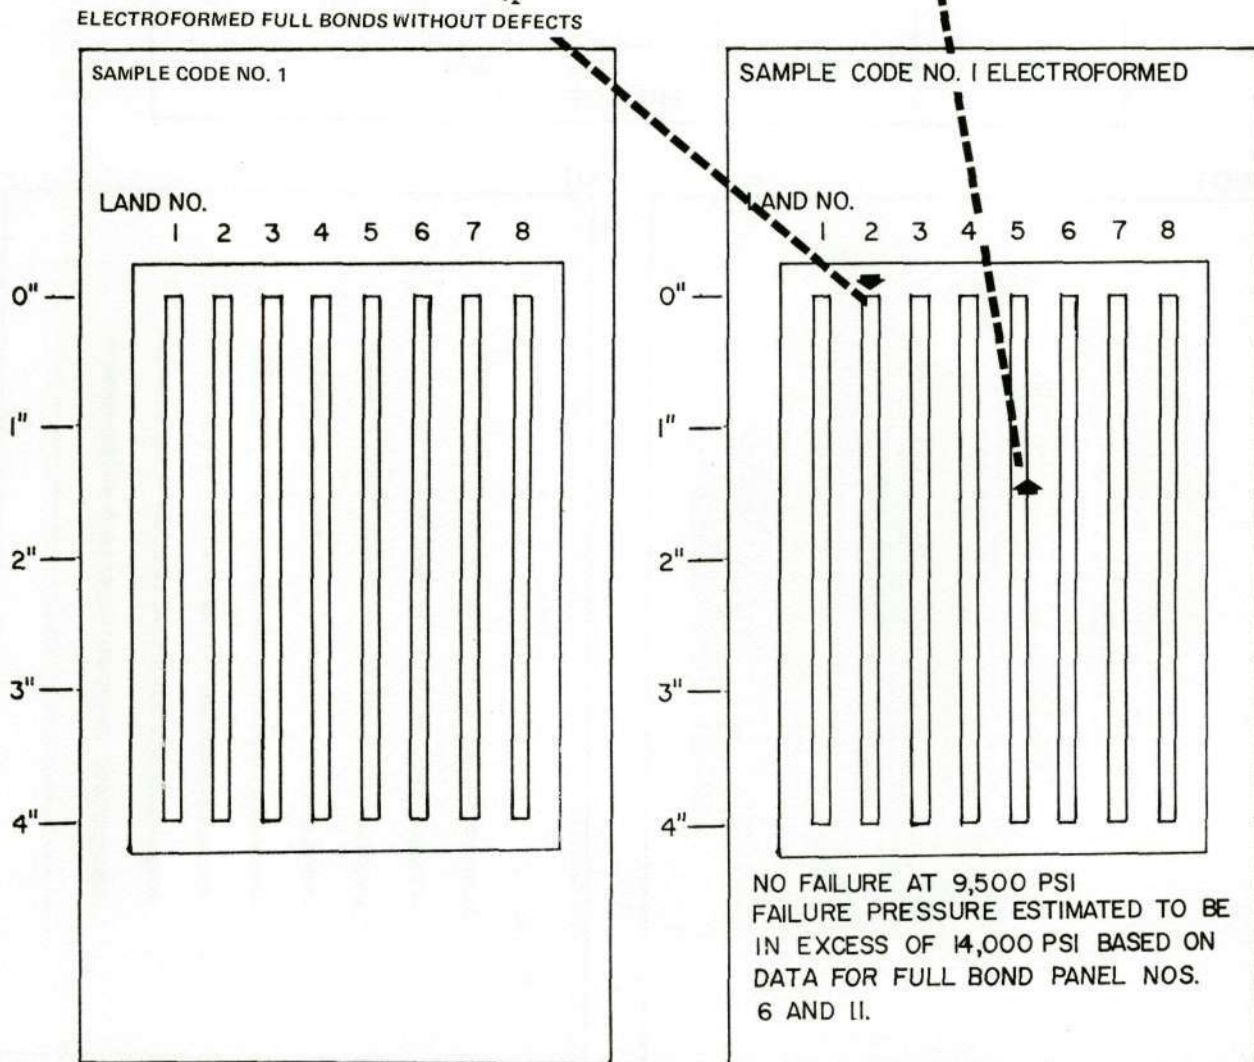
FIGURE A-3

TEST RESULTS ON ELECTROFORMED FULL BOND PANEL NO. 1

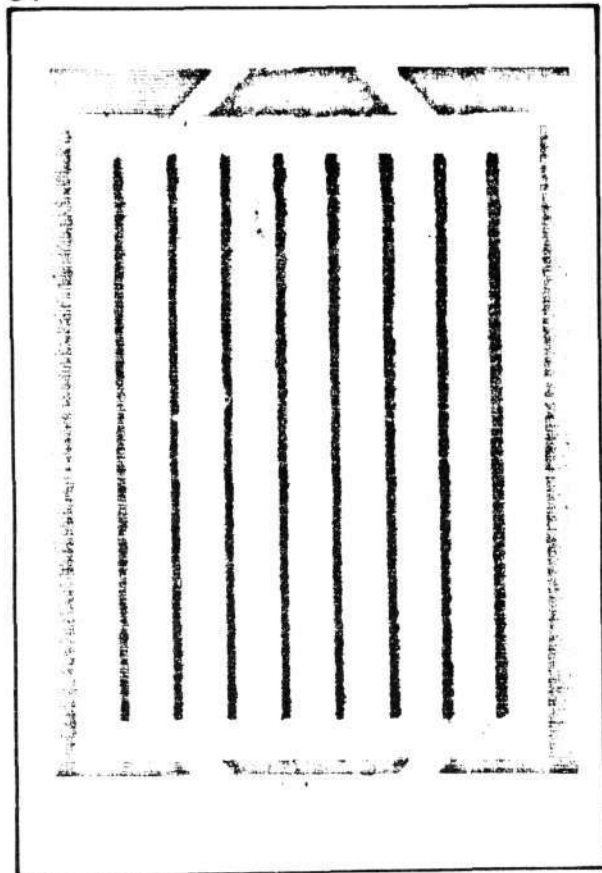
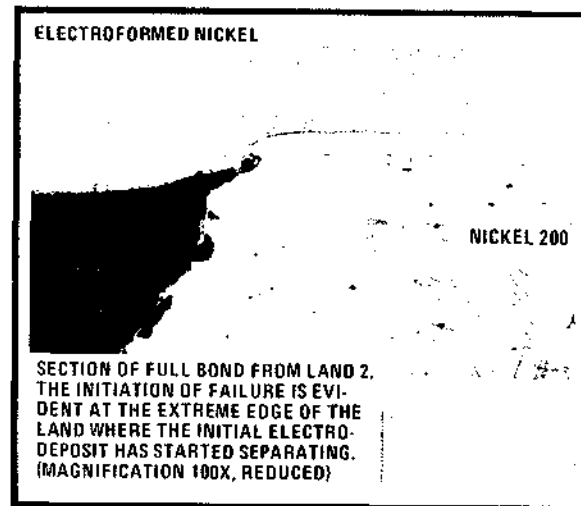
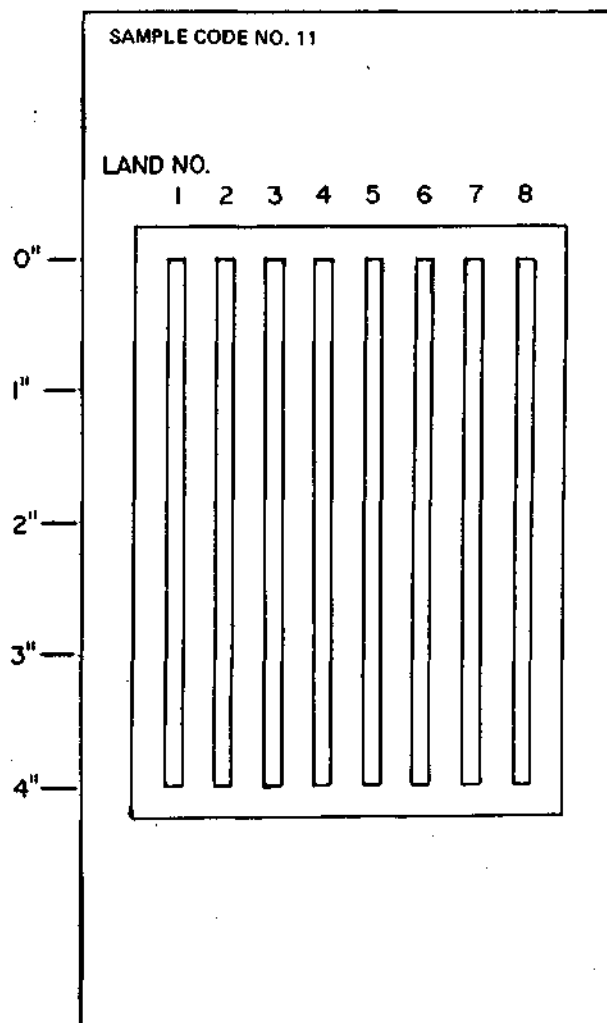
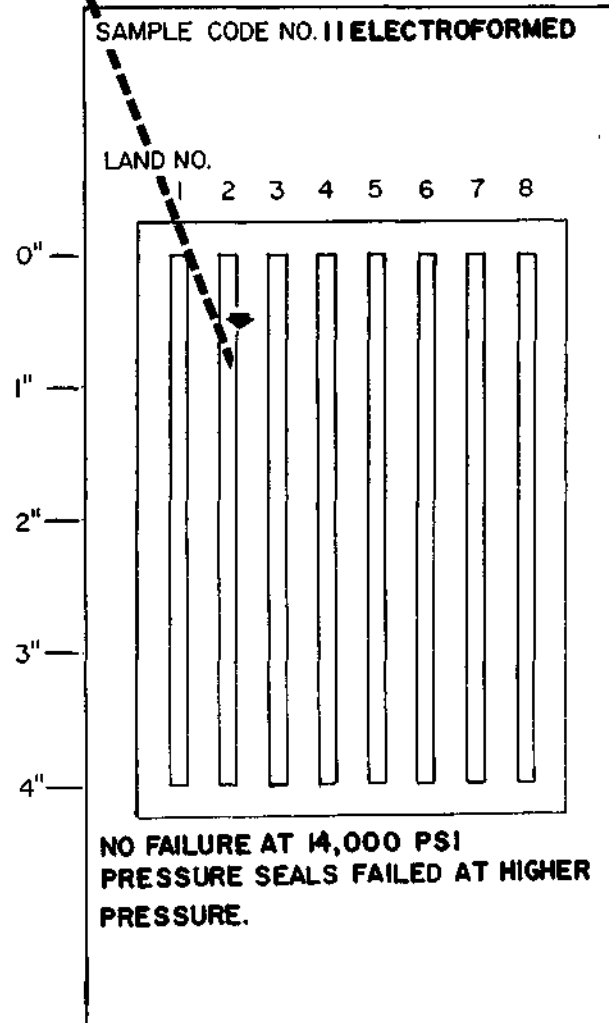
**FIGURE A-5.**

**ELECTROFORMED FULL BONDS WITHOUT DEFECTS**

**TEST RESULTS ON ELECTROFORMED FULL BOND PANEL NO. 11**

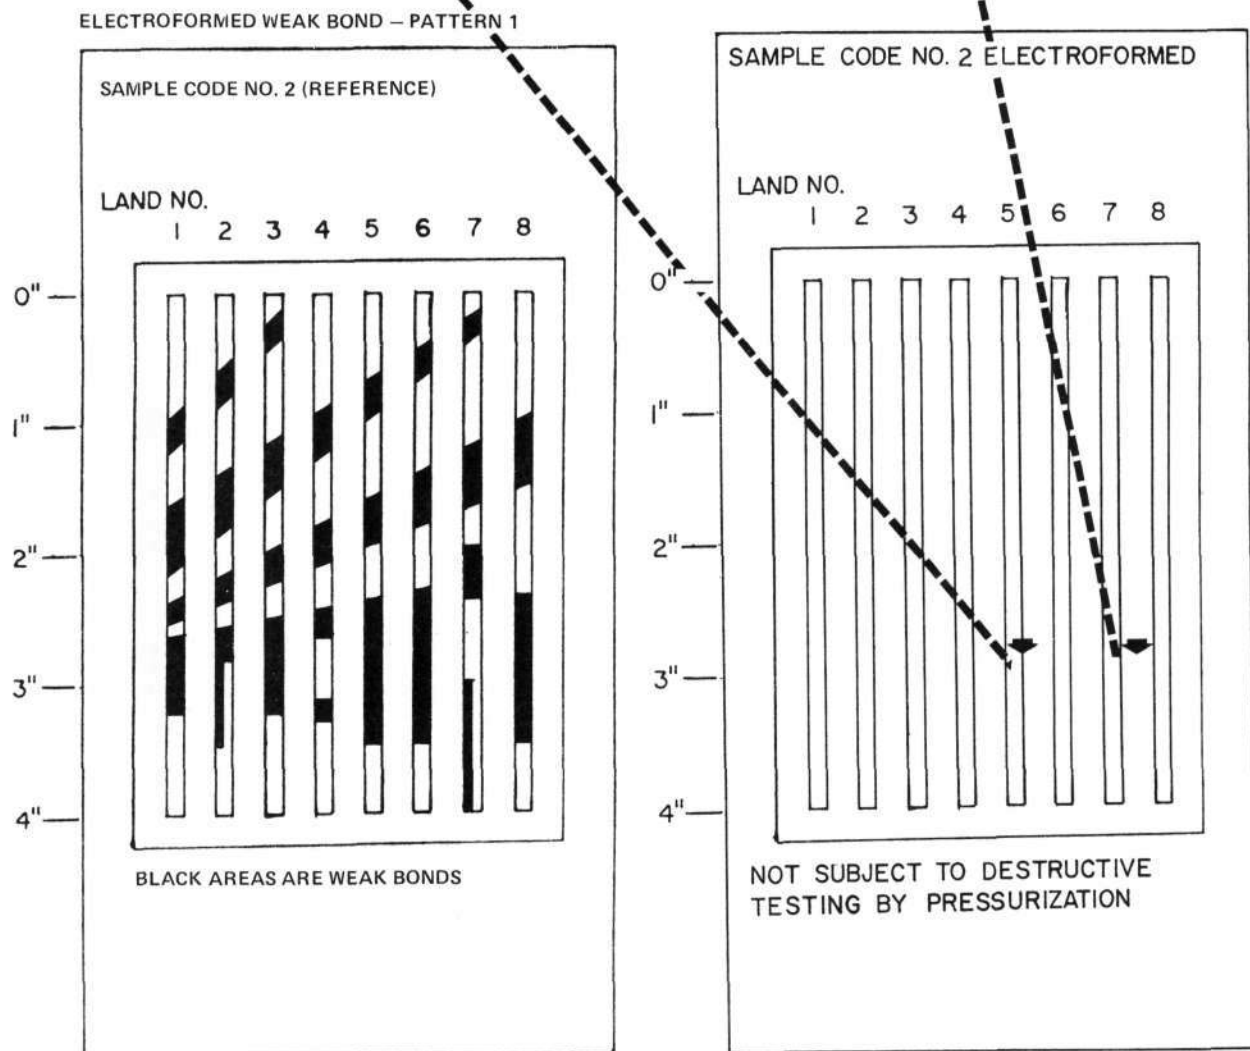
FIGURE A-6

TEST RESULTS ON ELECTROFORMED WEAK BOND PANEL NO. 2

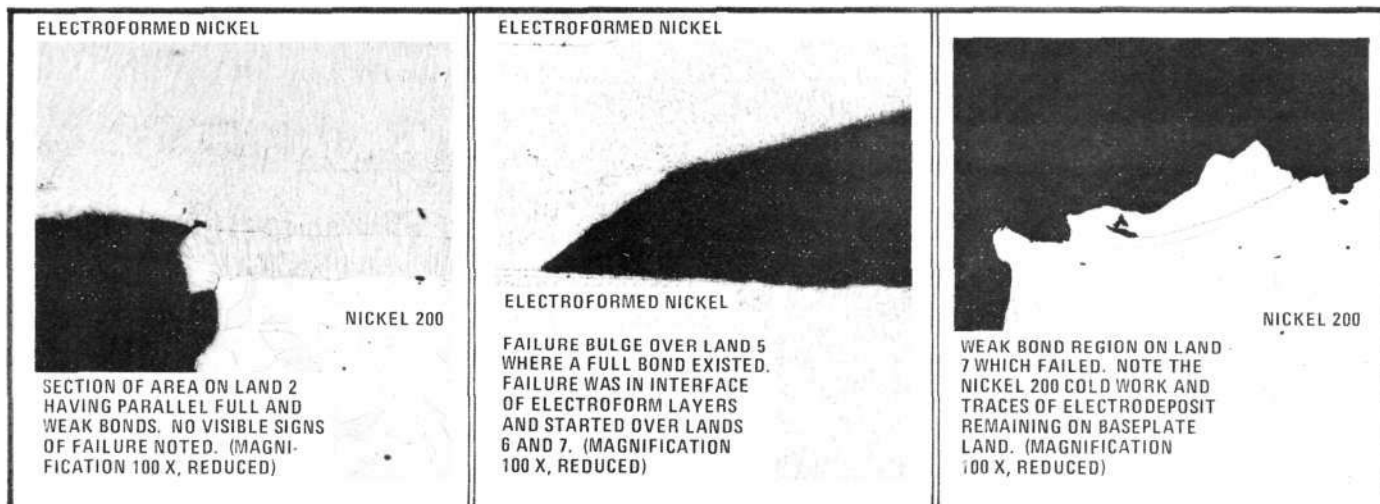
FIGURE A-7

**ELECTROFORMED WEAK BOND PATTERN 1**

TEST RESULTS ON ELECTROFORMED WEAK BOND PANEL NO. 13

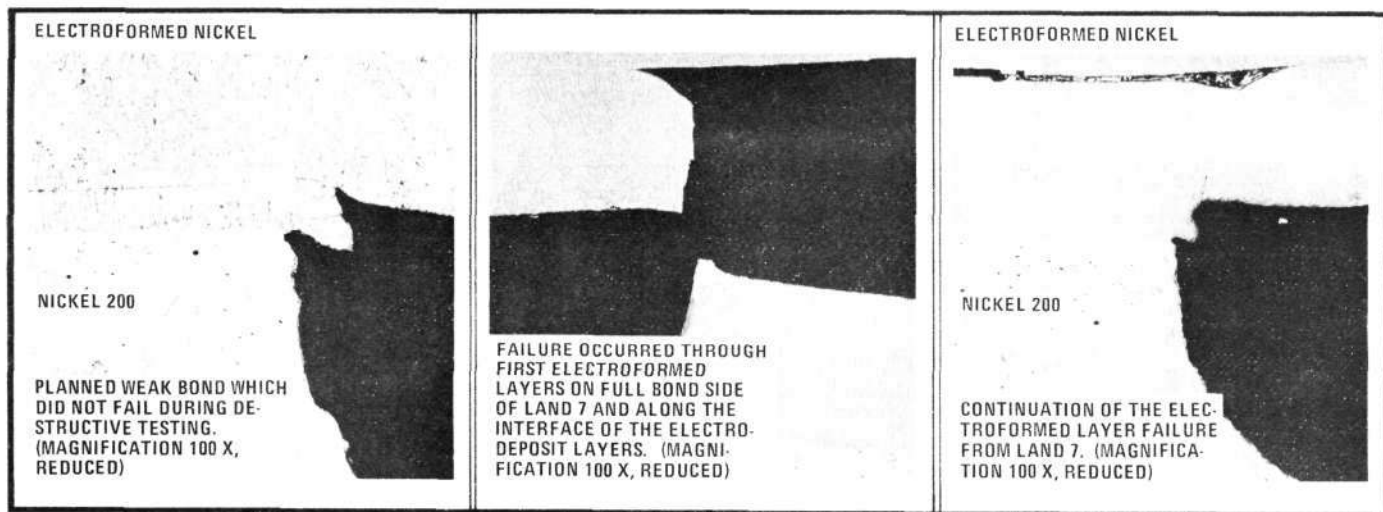
FIGURE A-8

# ELECTROFORMED WEAK BONDS - PATTERN 2

TEST RESULTS ON ELECTROFORMED WEAK BOND PANEL NO. 5

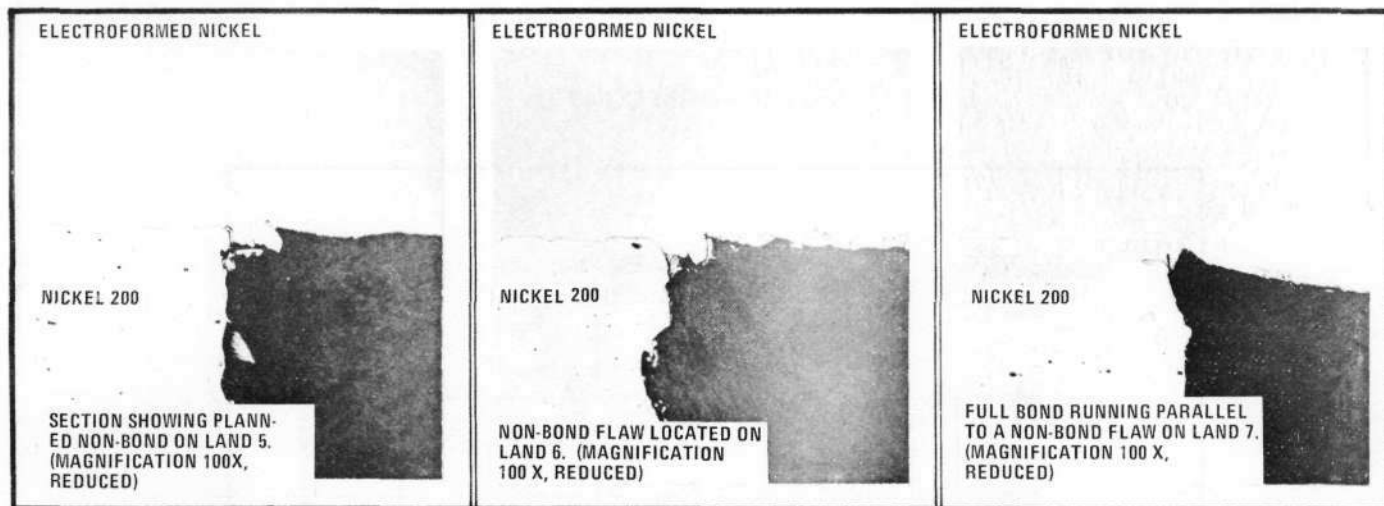
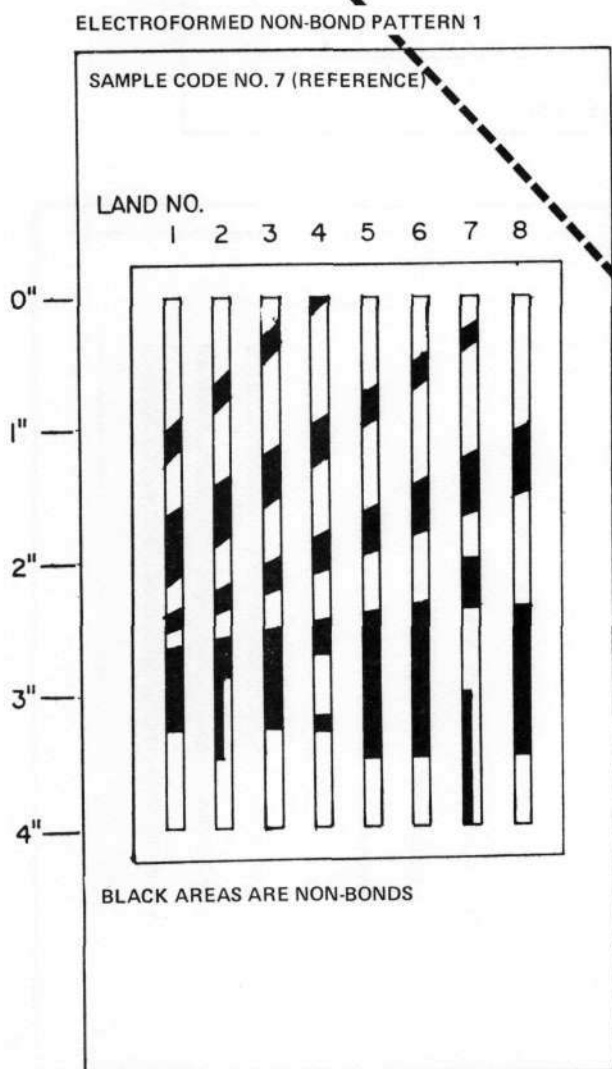
FIGURE A-11

TEST RESULTS ON ELECTROFORMED NON-BOND PANEL NO. 7

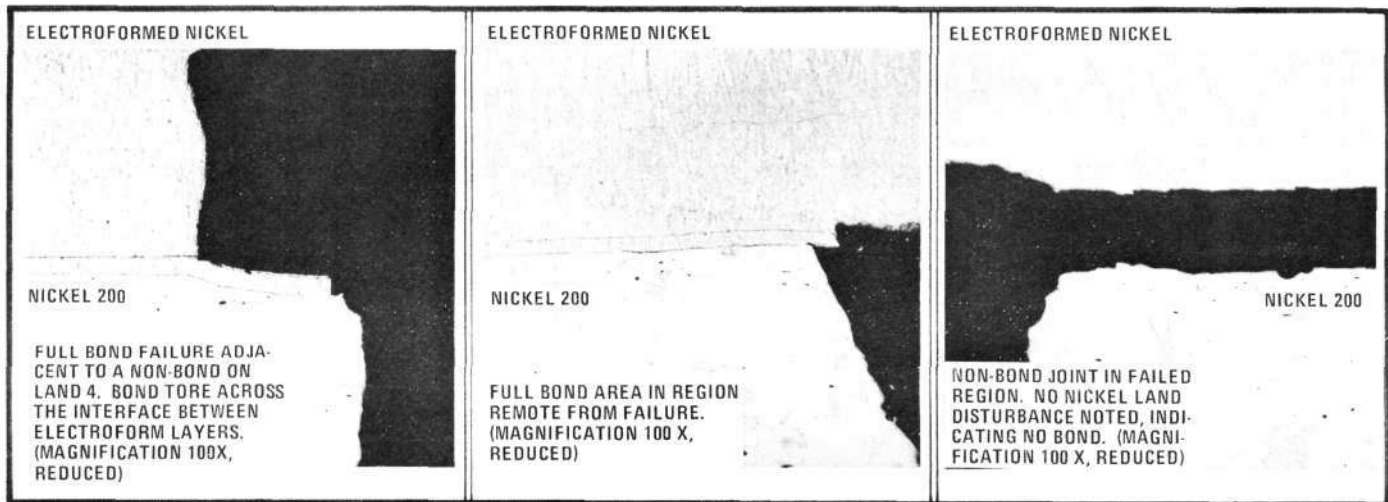
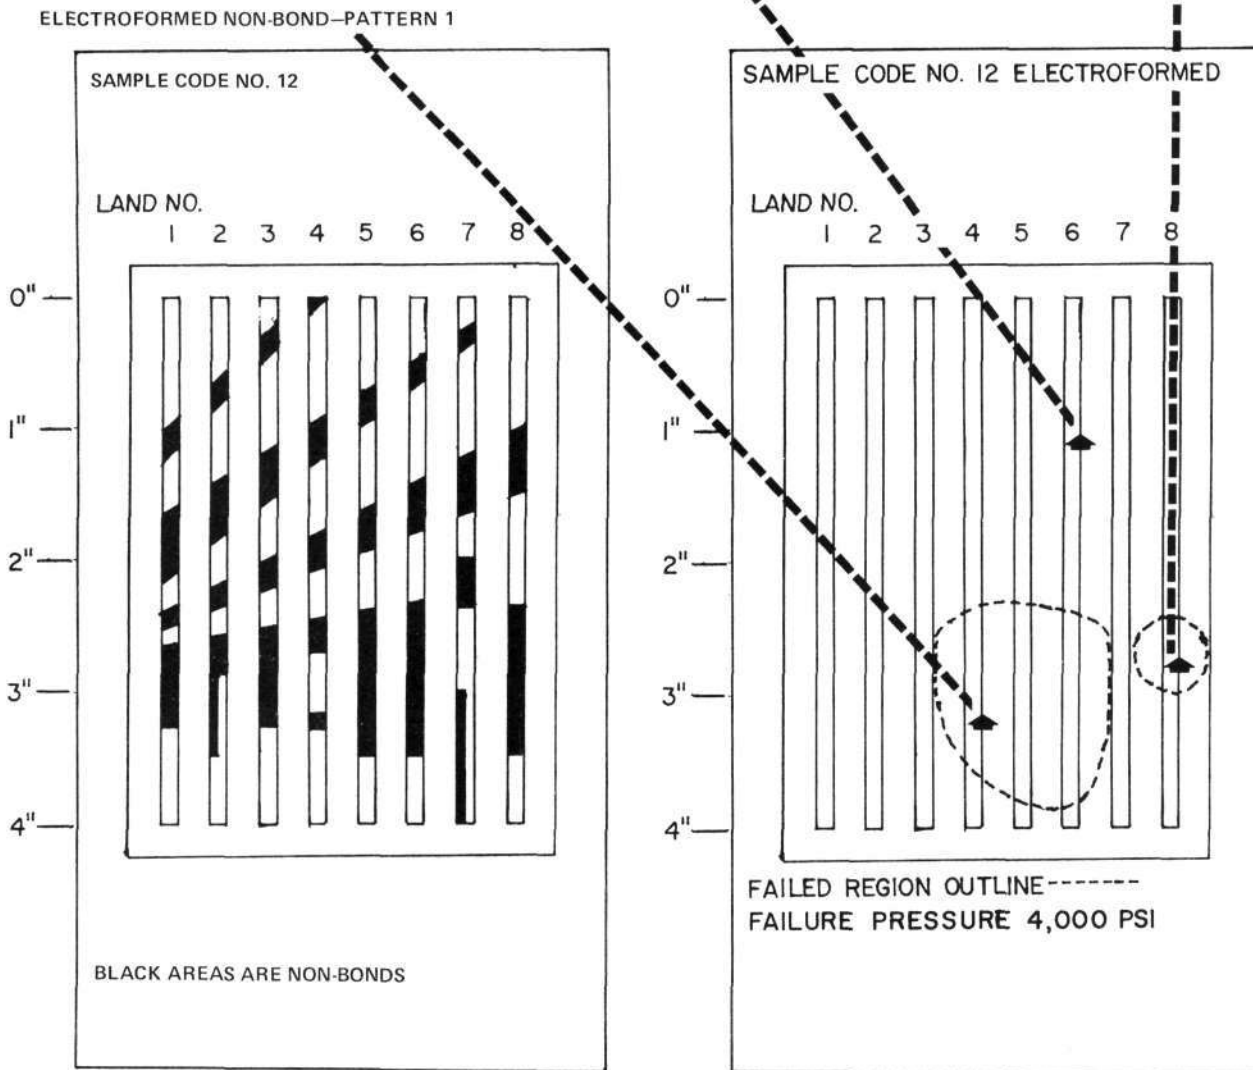
FIGURE A-12

TEST RESULTS FOR ELECTROFORMED NON-BOND PANEL NO. 12

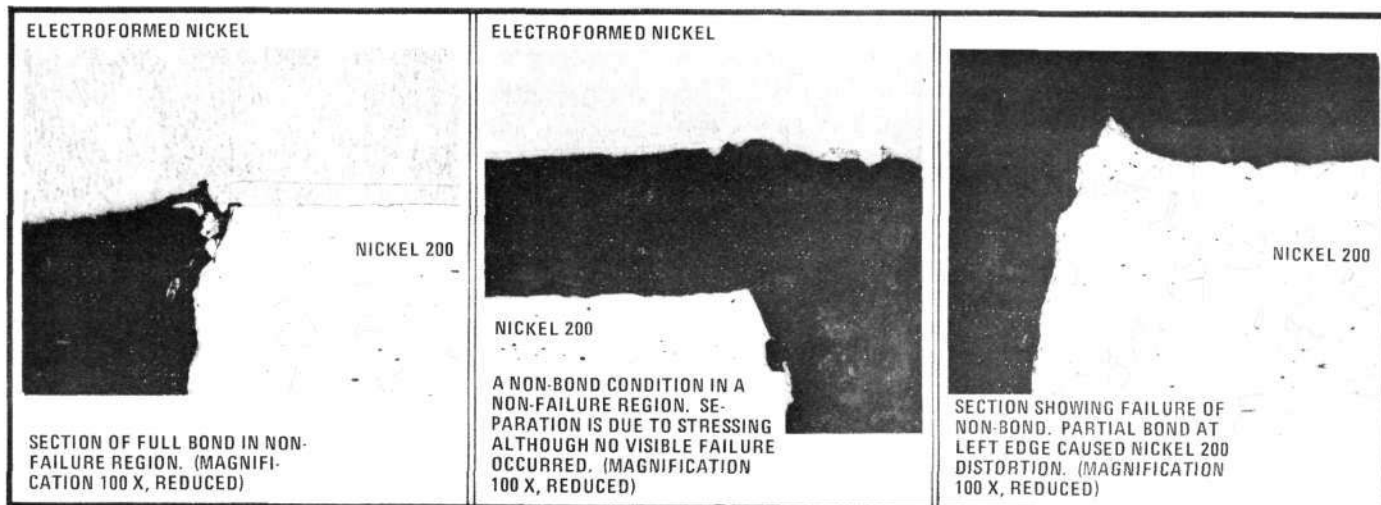
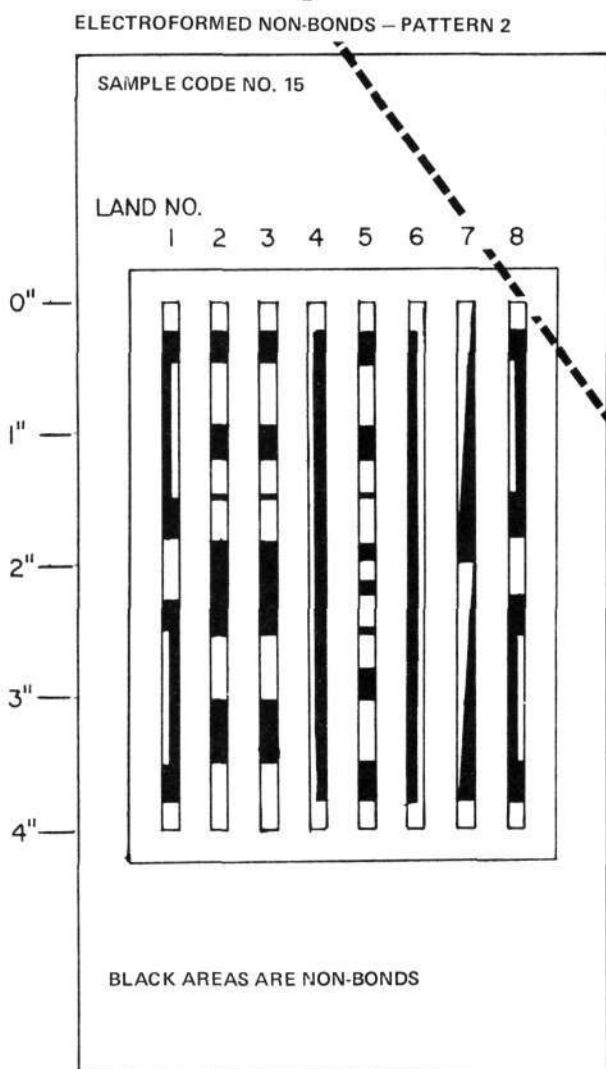
FIGURE A-14

TEST RESULTS FOR ELECTROFORMED NON-BOND PANEL NO. 15

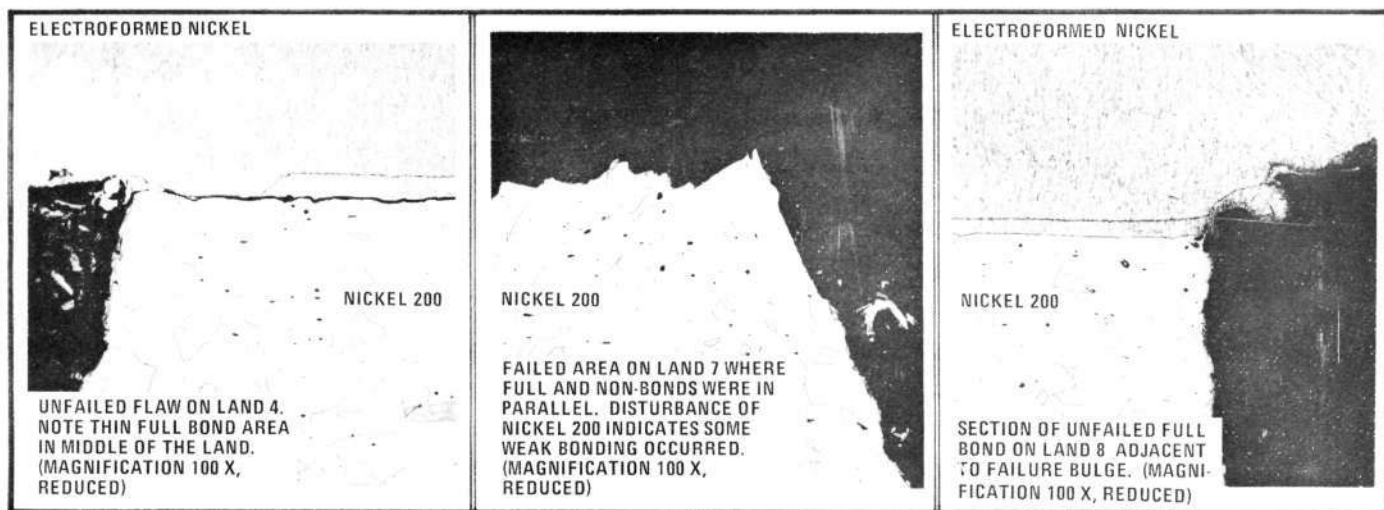
**FIGURE A-15**

**ELECTROFORMED NON-BONDS - PATTERN 3**

**TEST RESULTS ON ELECTROFORMED NON-BOND PANEL NO. 14**

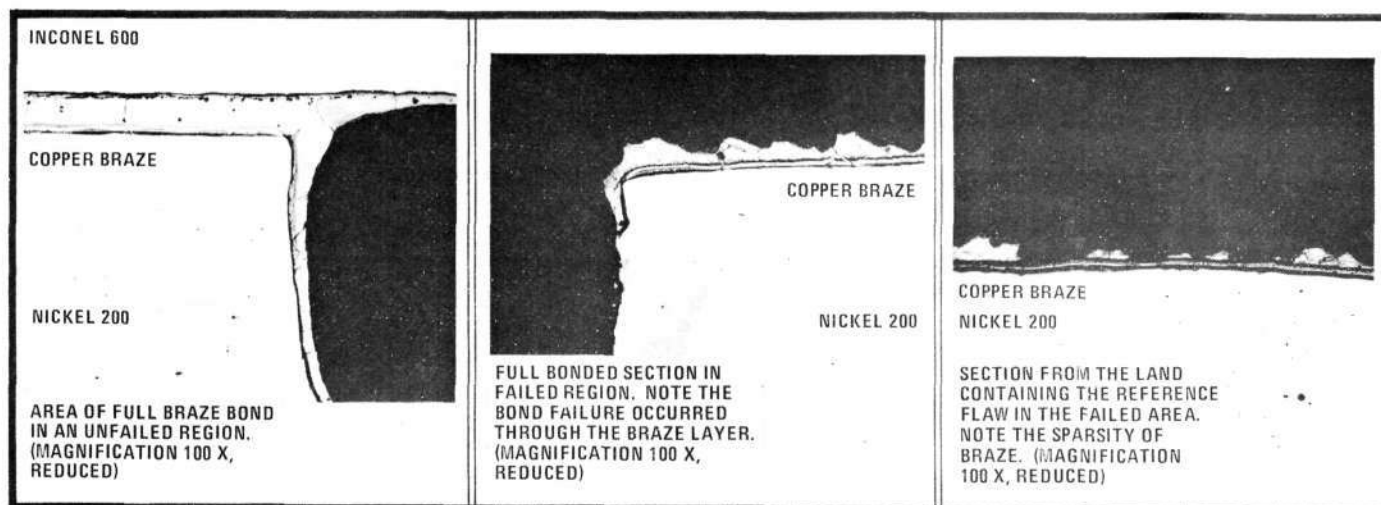
FIGURE A-16

TEST RESULTS ON BRAZED FULL BOND PANEL NO. 31

TEST PRESSURE 1420 PSI

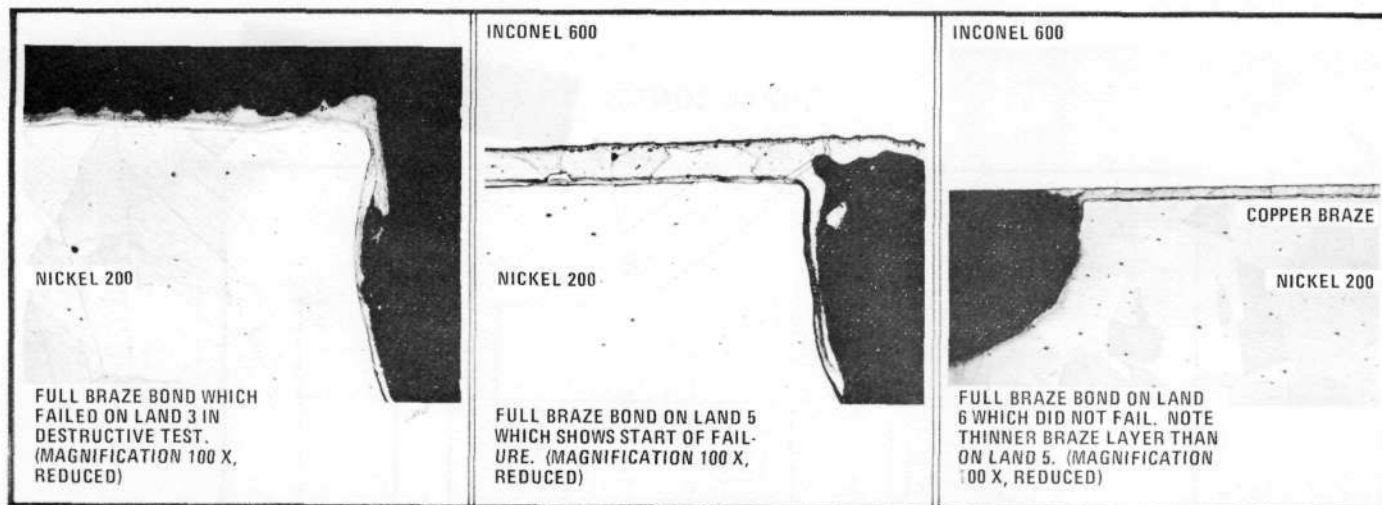
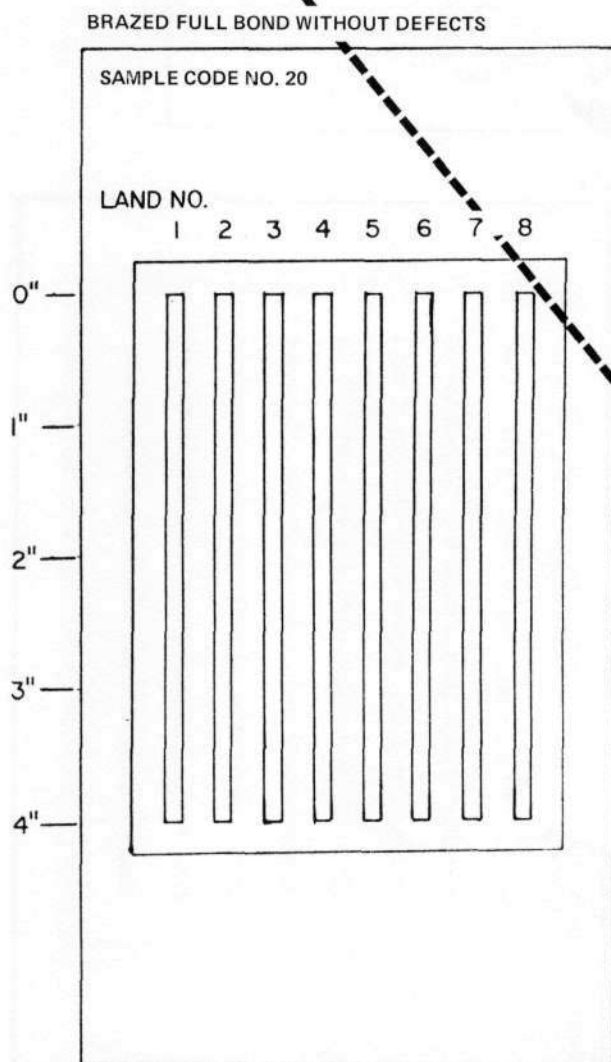
FIGURE A-17

TEST RESULTS ON BRAZED FULL BOND PANEL NO. 20

TEST PRESSURE 1380 PSI

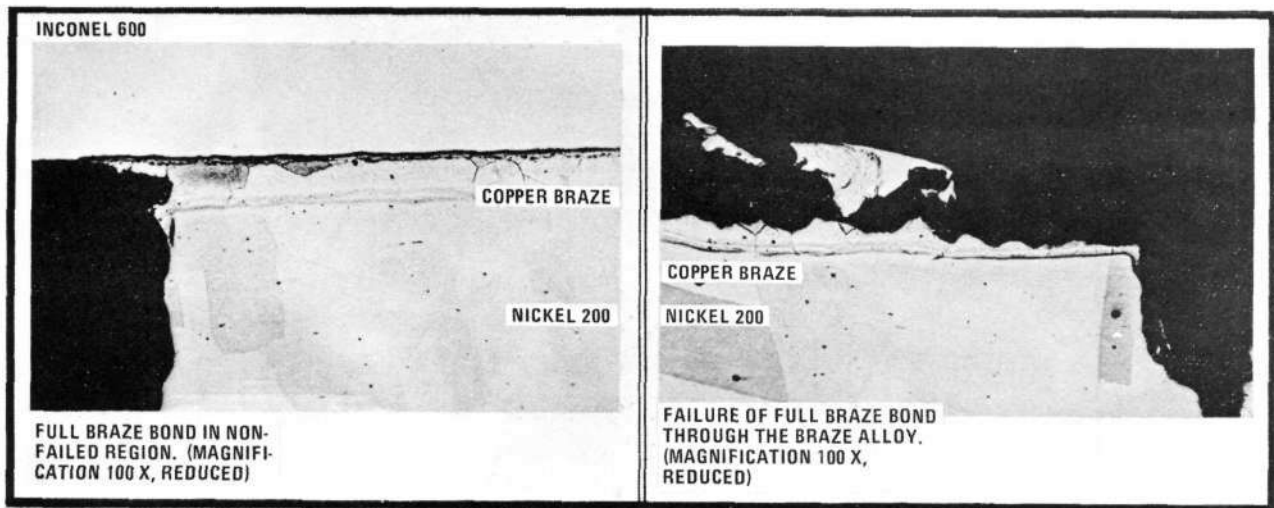
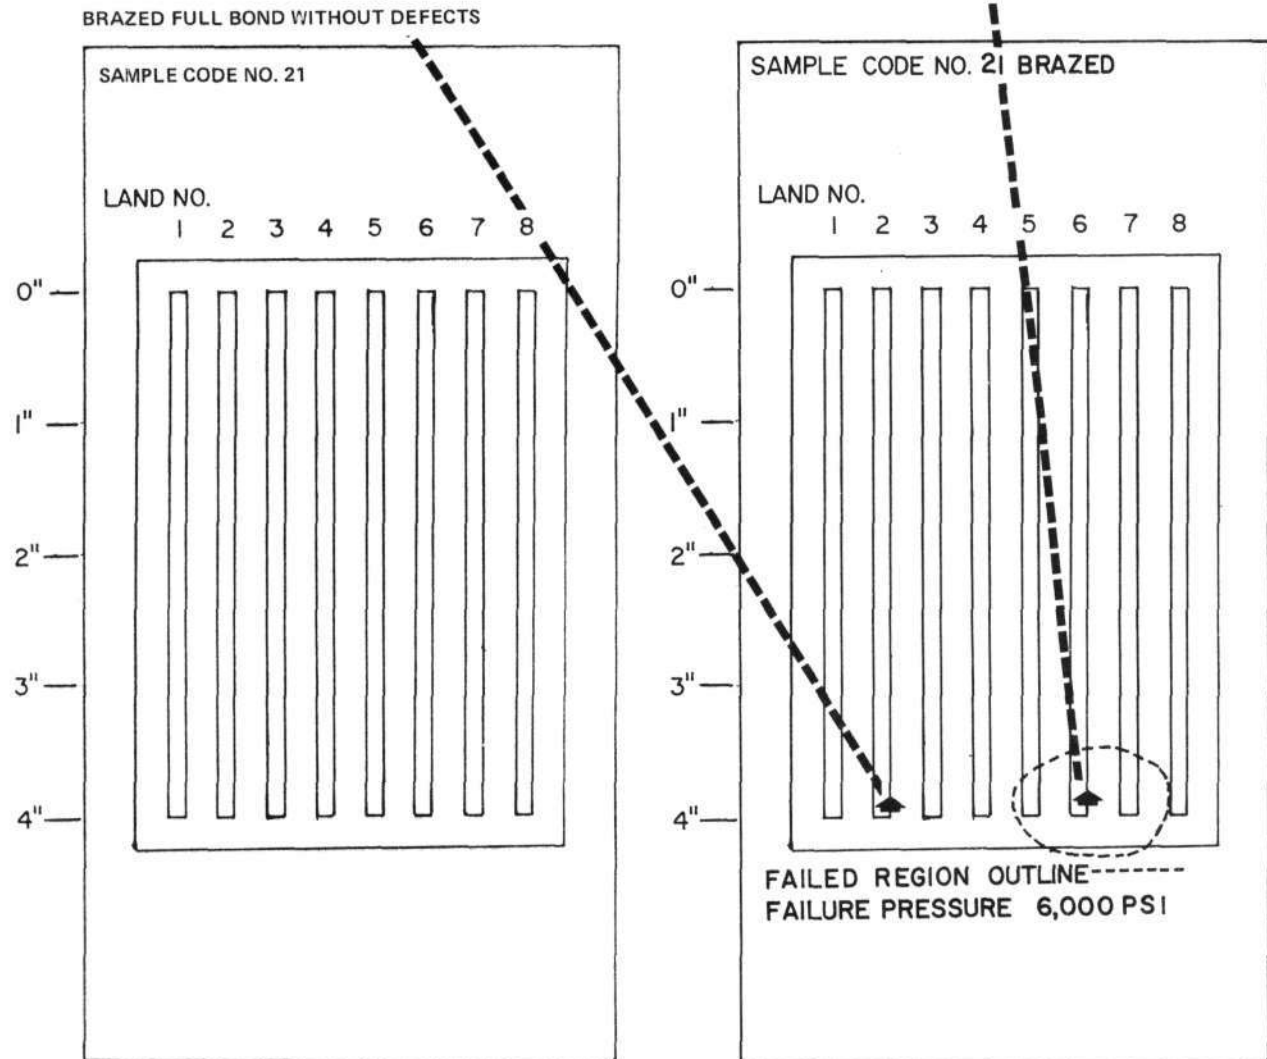
FIGURE A-18

TEST RESULTS FOR BRAZED FULL BOND PANEL NO. 21

TEST PRESSURE 1360 PSI

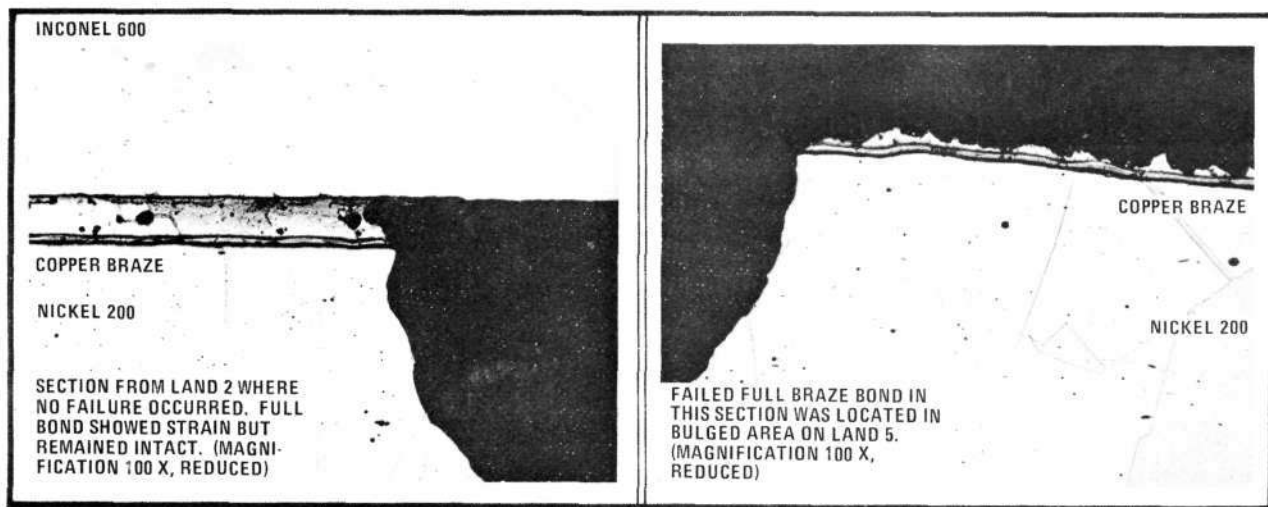
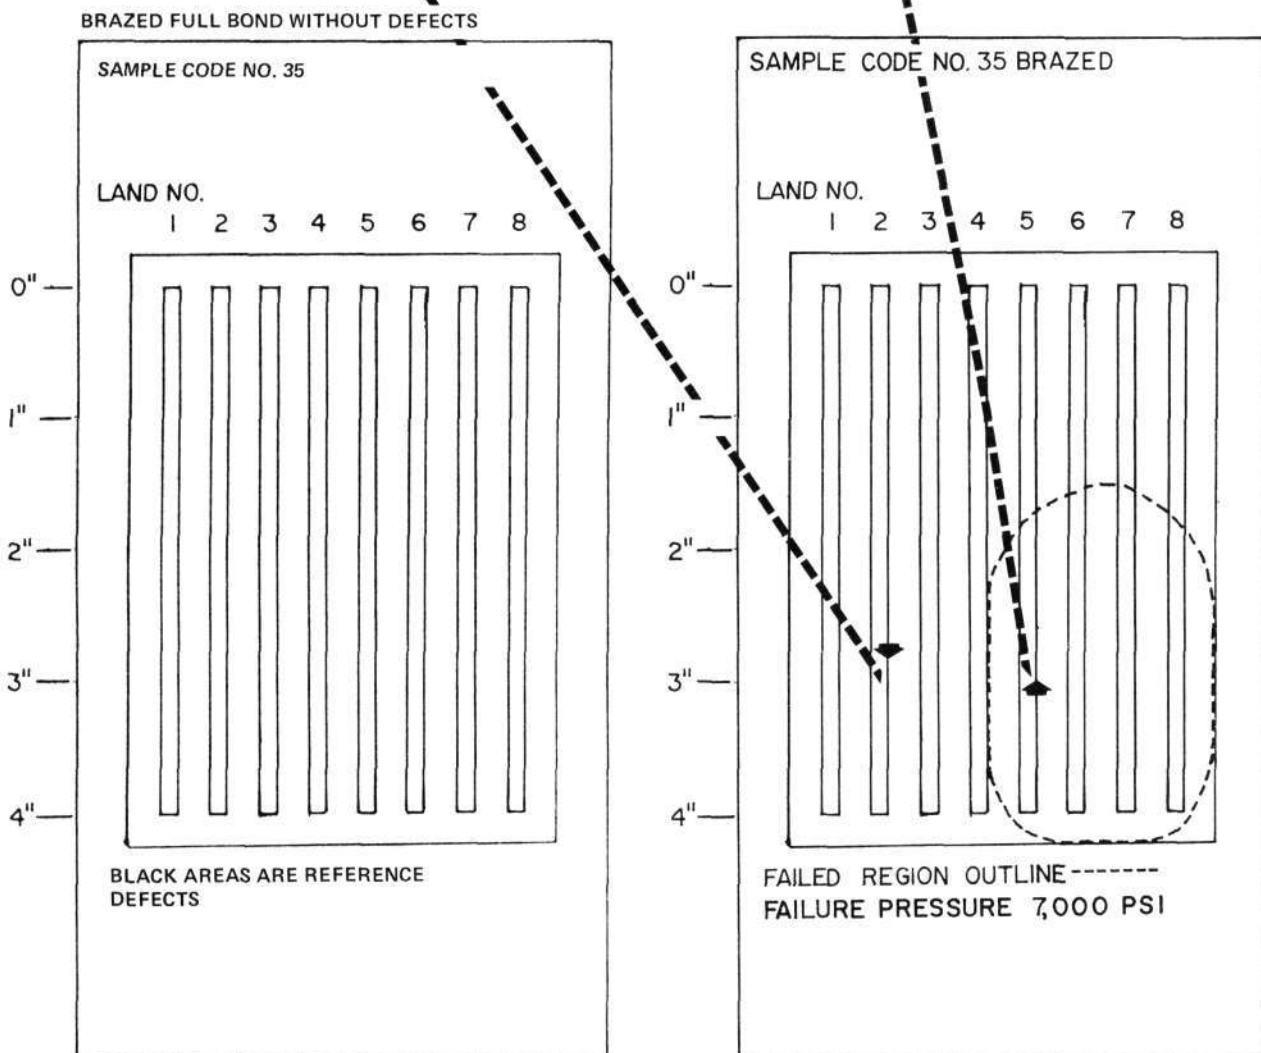
FIGURE A-19

TEST RESULTS ON BRAZED FULL BOND PANEL NO. 35

TEST PRESSURE 1460 PSI

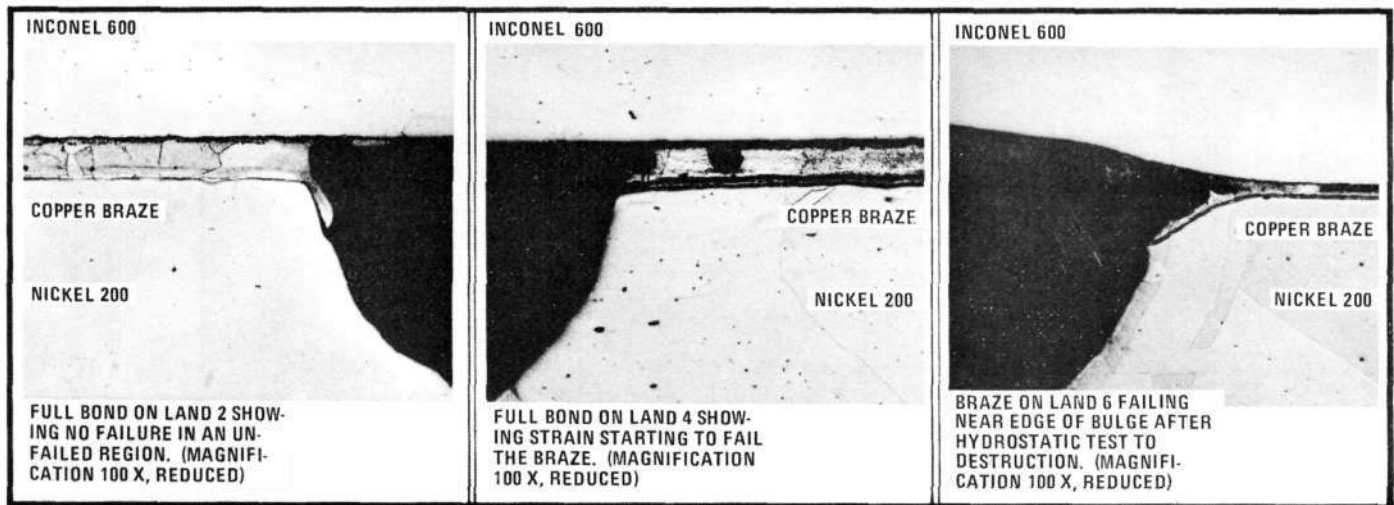
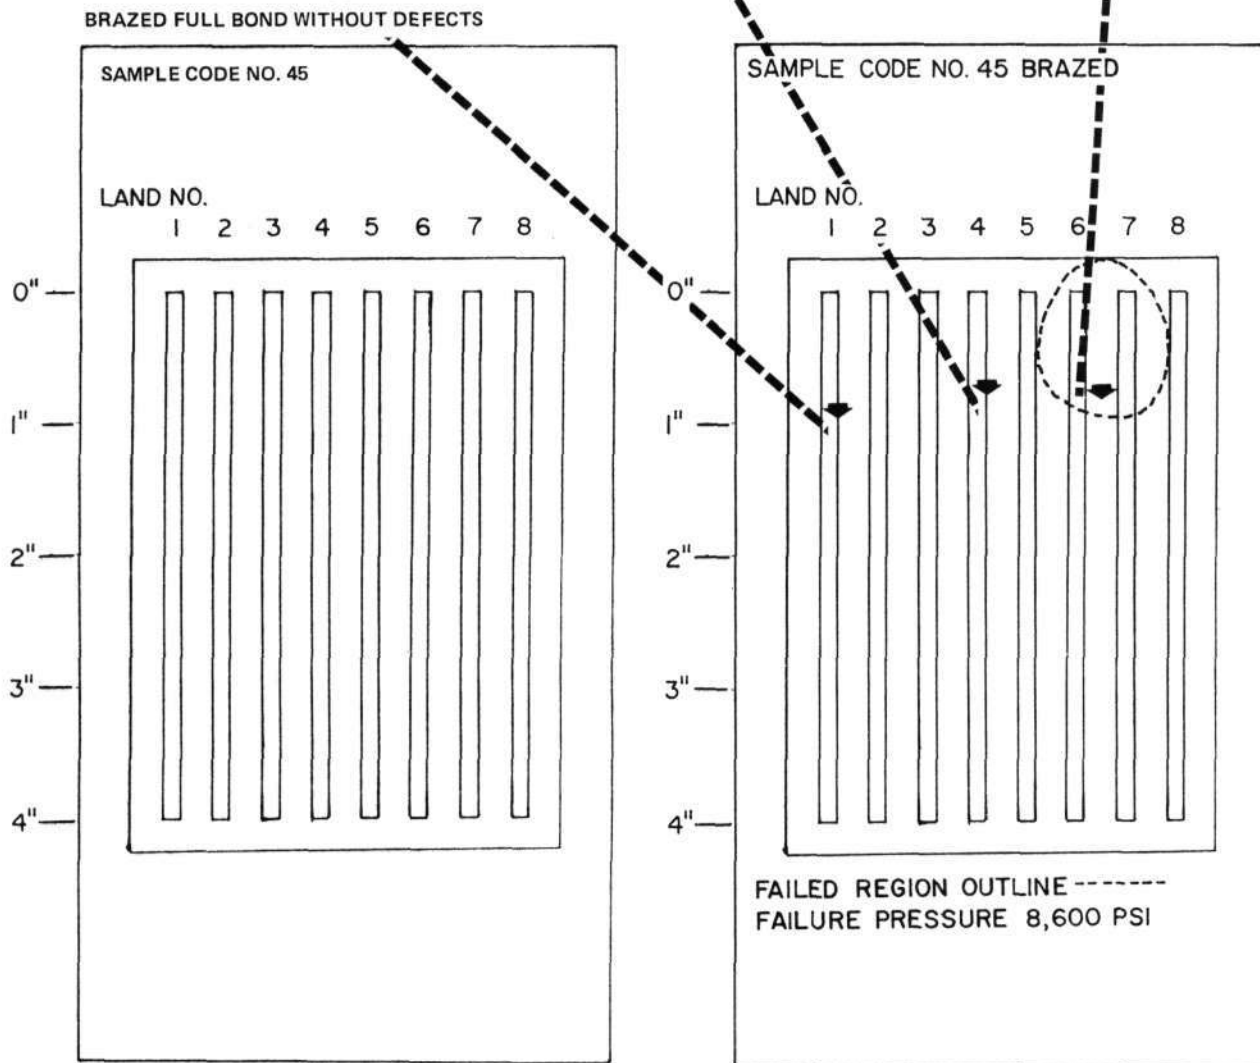
FIGURE A-20

TEST RESULTS ON BRAZED FULL BOND PANEL NO. 45

TEST PRESSURE 1400 PSI
